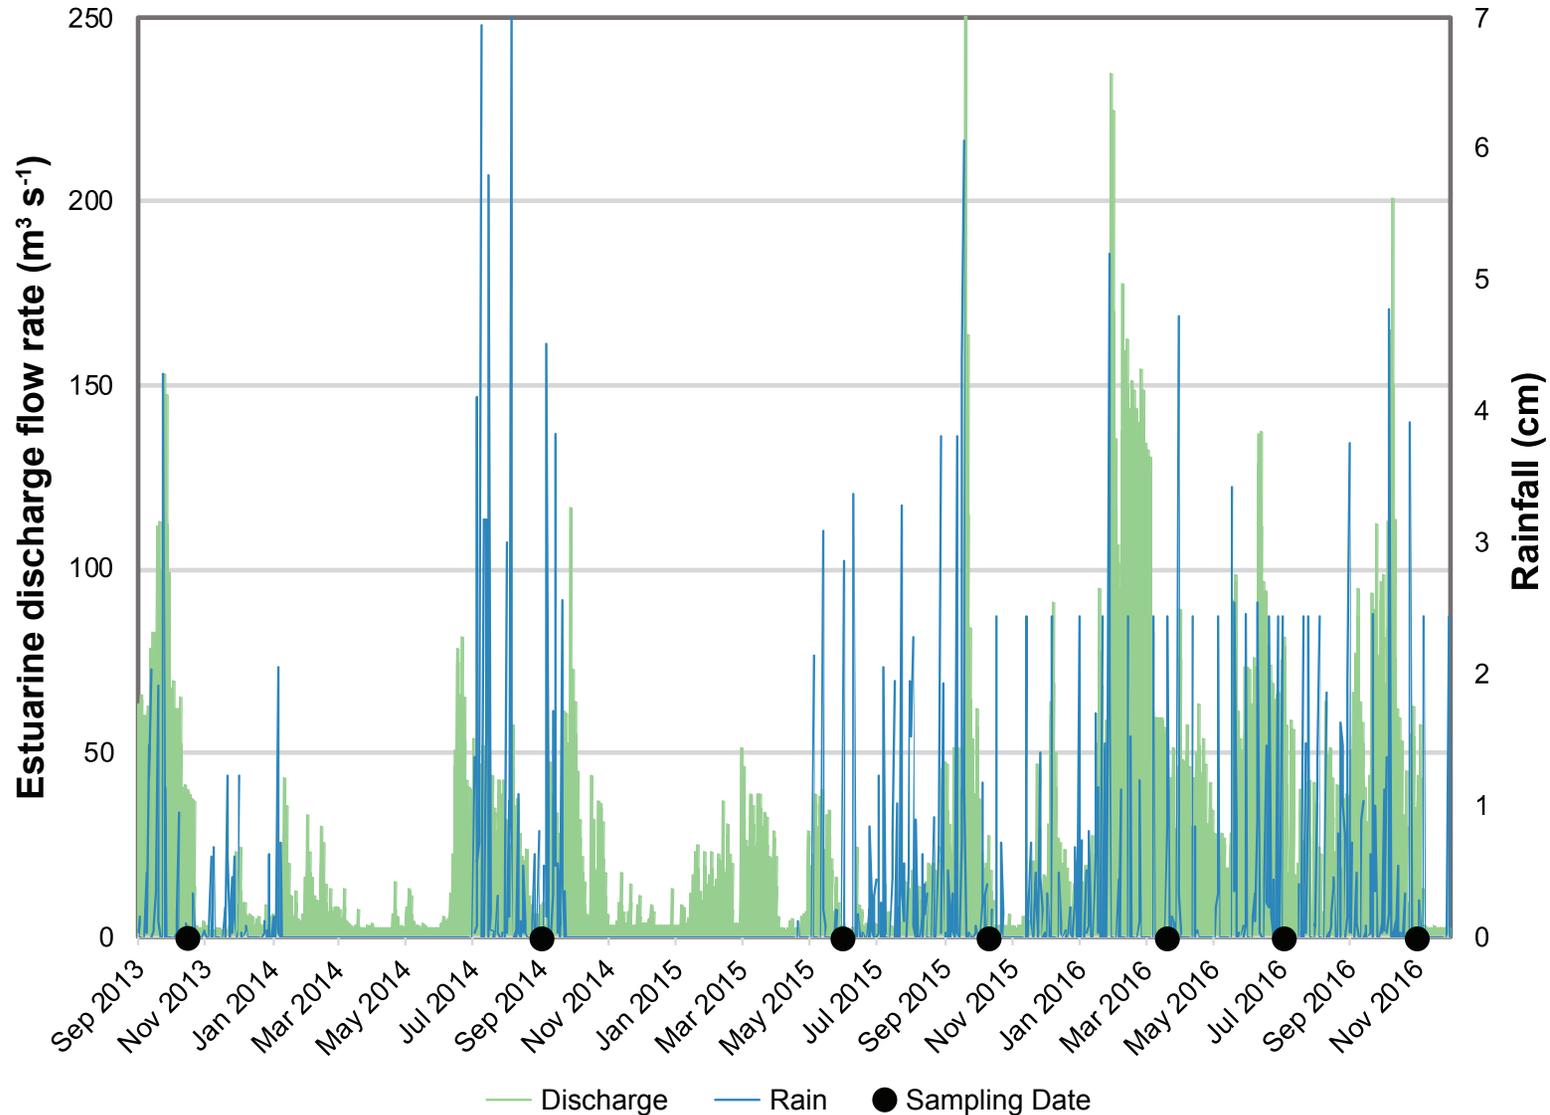
Figure S1. Cumulative estuarine discharge flow rates ($\text{m}^3 \text{s}^{-1}$) and daily rainfall (cm) measured at canals C-44, C-23, C-24, and Ten Mile Creek, with sampling time points for the *in situ* experiment denoted as black circles. Data were obtained from the South Florida Water Management District's DBHYDRO database.
